Report on
Salinity Investigation and Salinity Management Plan

Stage 1 Birling Property
Proposed Residential Subdivision
975 The Northern Road, Bringelly, NSW

Project 204684.01
June 2022

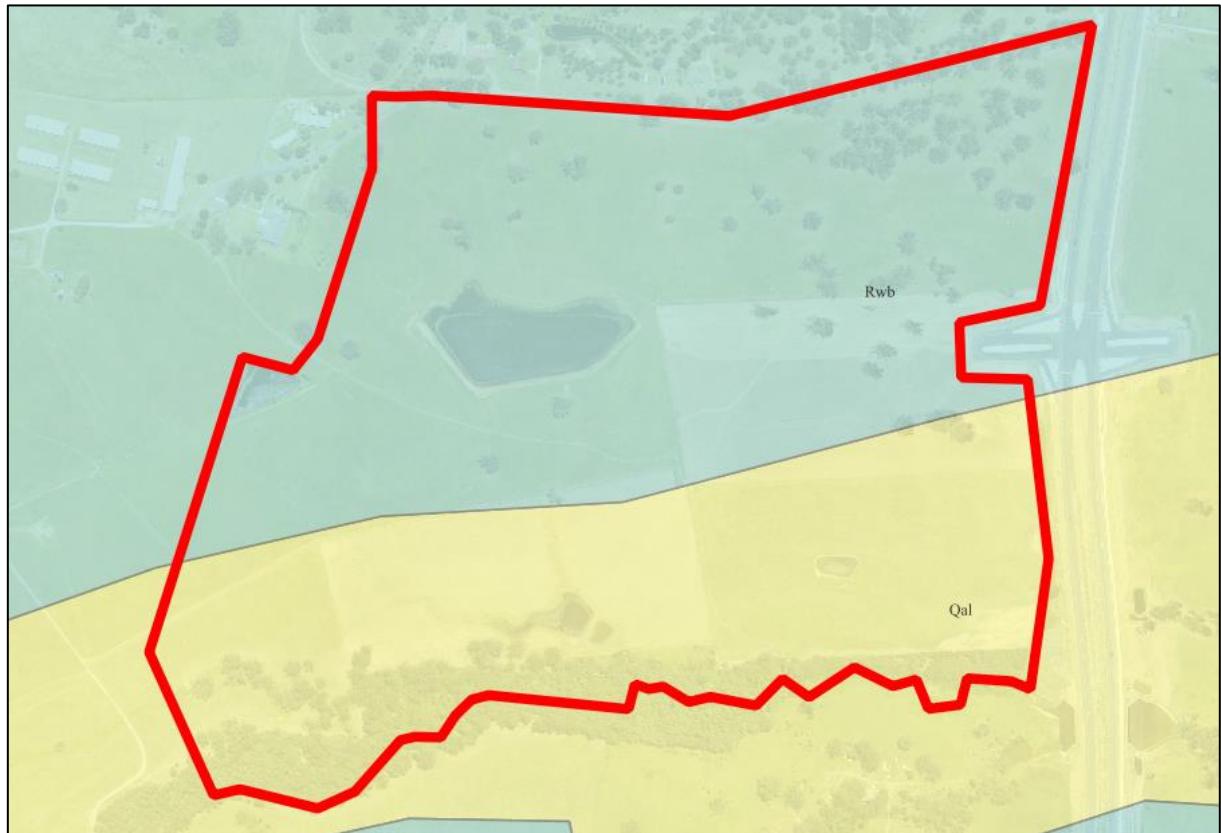
Figure 2: Site geology based on regional mapping

Triassic age. Bringelly shale comprises of shale, carbonaceous claystone, laminitite, lithic sandstone and rare coal. The remainder of the site on the southern portion next to and below Lowes Creek is underlain by Alluvial floodplain deposits of the Quaternary (base) (Qal) to Now (top) age. Alluvial floodplain deposits typically comprise of silt, very fine-to medium-grained lithic to quartz-rich sand and clay. The site geology based on regional mapping is presented in Figure 2 below.

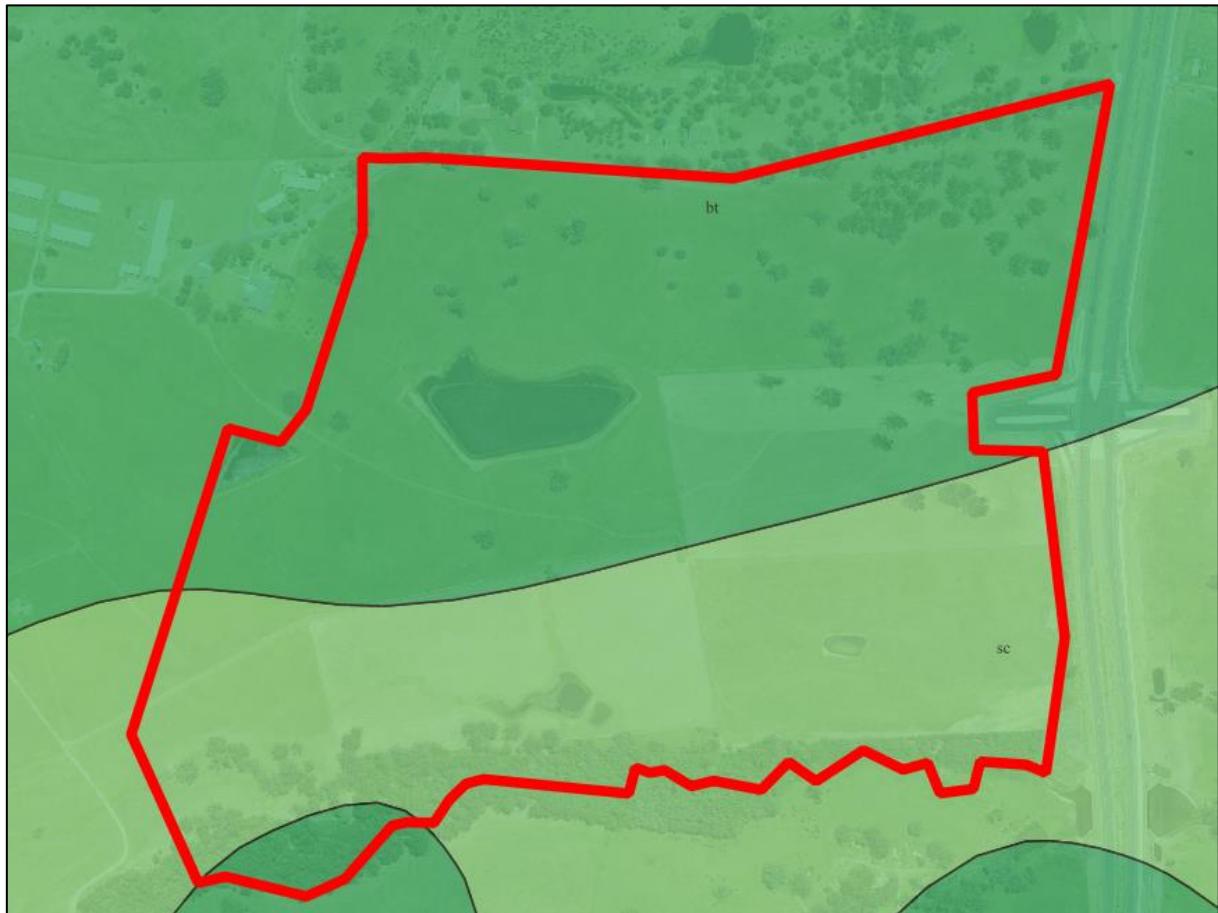
Figure 3: Soils based on regional mapping

Reference to the *Penrith 1: 100, 000 Soils Landscape Sheet 9030, 1989*, indicates that approximately two-thirds of the northern portion of the site is underlain by Blacktown soils (mapping unit bt), which is a residual soils group associated with gently undulating rises, broad rounded crests, and ridges with gently inclined slopes. The unit comprises of shallow to moderately deep (<100 cm) red and brown podzolic soils on crests, upper slopes and in well-drained areas. In areas of greater depth (150-300 cm), there are yellow podzolic soils and soloths on lower slopes and in areas of poor drainage (Sydney). Local relief is to 30 m, slopes are usually <5%. These soils are typically of low fertility, are moderately reactive, with high plasticity in the subsoil, and generally have poor soil drainage.

The remaining one-third of the site on the southern portion is underlain by South Creek soils (mapping unit sc), which is an alluvial soils group associated with floodplains, valley flats and drainage depressions of the channels on the Cumberland Plain, usually flat with incised channels. The unit comprises of red and yellow podzolic soils on terraces with small areas of structured grey clays, leached clay and yellow solodic soils. It also comprises of often very deep layered sediments over bedrock or relict soils. Where pedogenesis has occurred, there are structured plastic clays or structured loams in and adjacent to drainage lines. These soils typically present an erosion hazard with frequent flooding. Regional mapping of soil landscapes for the site are presented in Figure 3 on the following page.

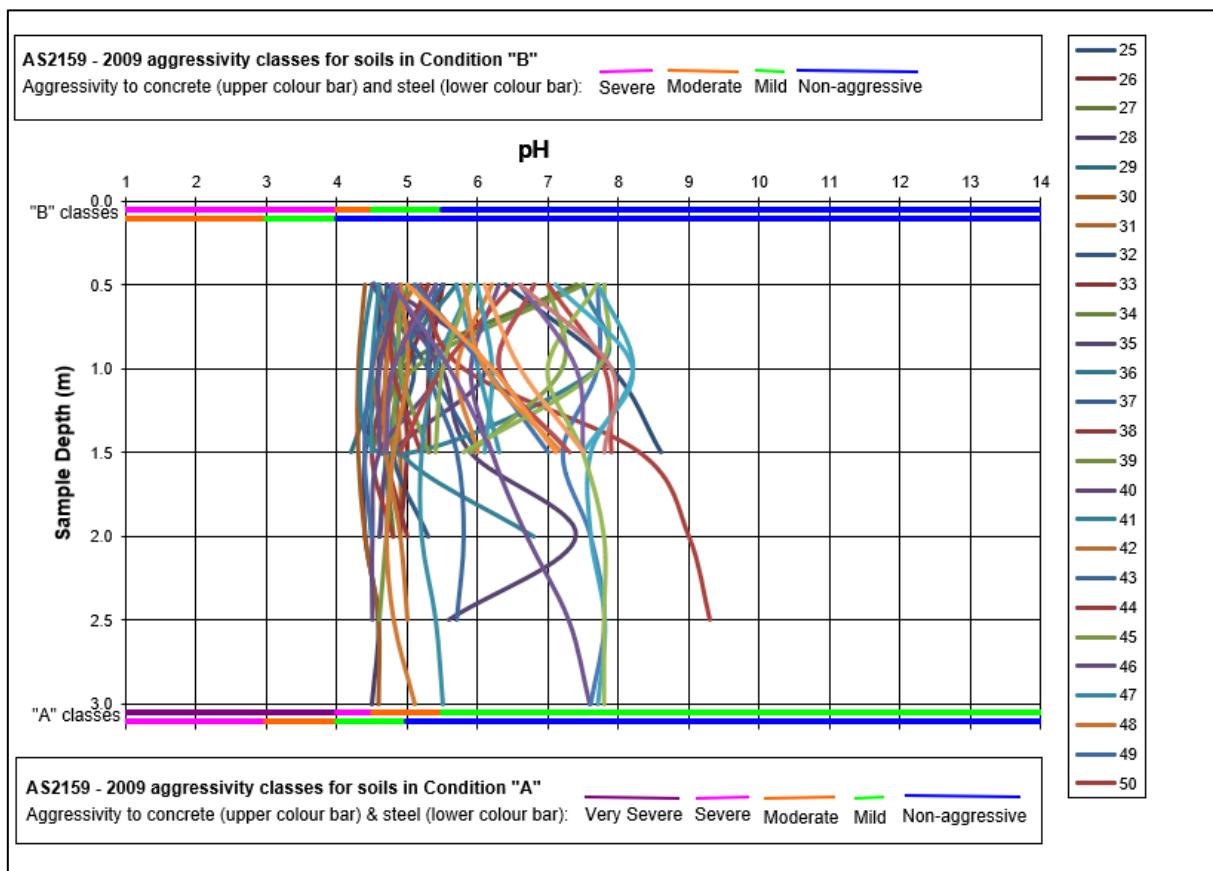
Figure 5. Vertical Soil pH Profiles and Aggressivity Classes

Figure 5 below, presents variations of aggressivity with depth at each test pit location, based on pH profiles, and the corresponding aggressivity class ranges as per the Australian Standard AS 2159 (2009). Due to the clay/silt composition of the soils, all samples were classed as Condition B as defined by AS 2159.

Figure 5 shows that the site was underlain by soils which are non-aggressive to moderately aggressive to concrete foundations and concrete piles based on pH values. The summary table (Appendix D) indicates that 44% of soil samples were non-aggressive to concrete, 53% were mildly aggressive and 4% were moderately aggressive. It is noted that 11 samples had a pH of 4.5 which is at the crossover for the classification of moderately aggressive and mildly aggressive soils.

The worst-case pH results for each test pit were used to define approximate areas of mild and moderate aggressivity to concrete foundations and piles within the site, as represented by colour zones on Drawing 2 (Appendix A). Based on a review of the results, test pits which reported samples with a pH of 4.5 and did not have any addition samples which had a pH result of <4.5 were considered mildly aggressive to concrete.

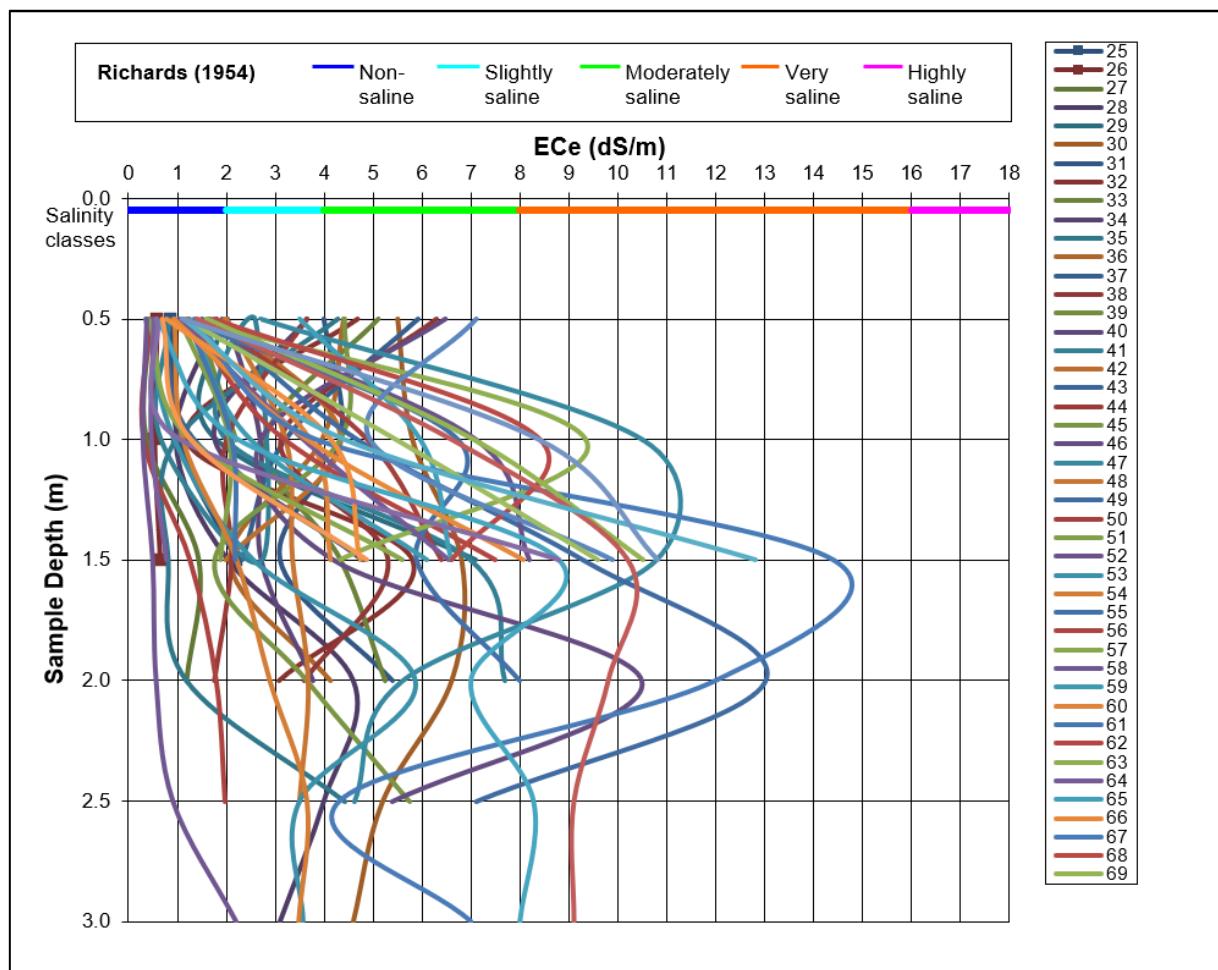
Figure 6: Vertical Soil Salinity Profiles and Salinity Classes

Figure 6 below presents variations of salinity with depth at each test pit location, based on ECe profiles, and the corresponding salinity classifications of Richards (1954).

Table D1 (Appendix D) indicates that 33% of all samples were non-saline, 25% were slightly saline, 31% were moderately saline and 11% were very saline.

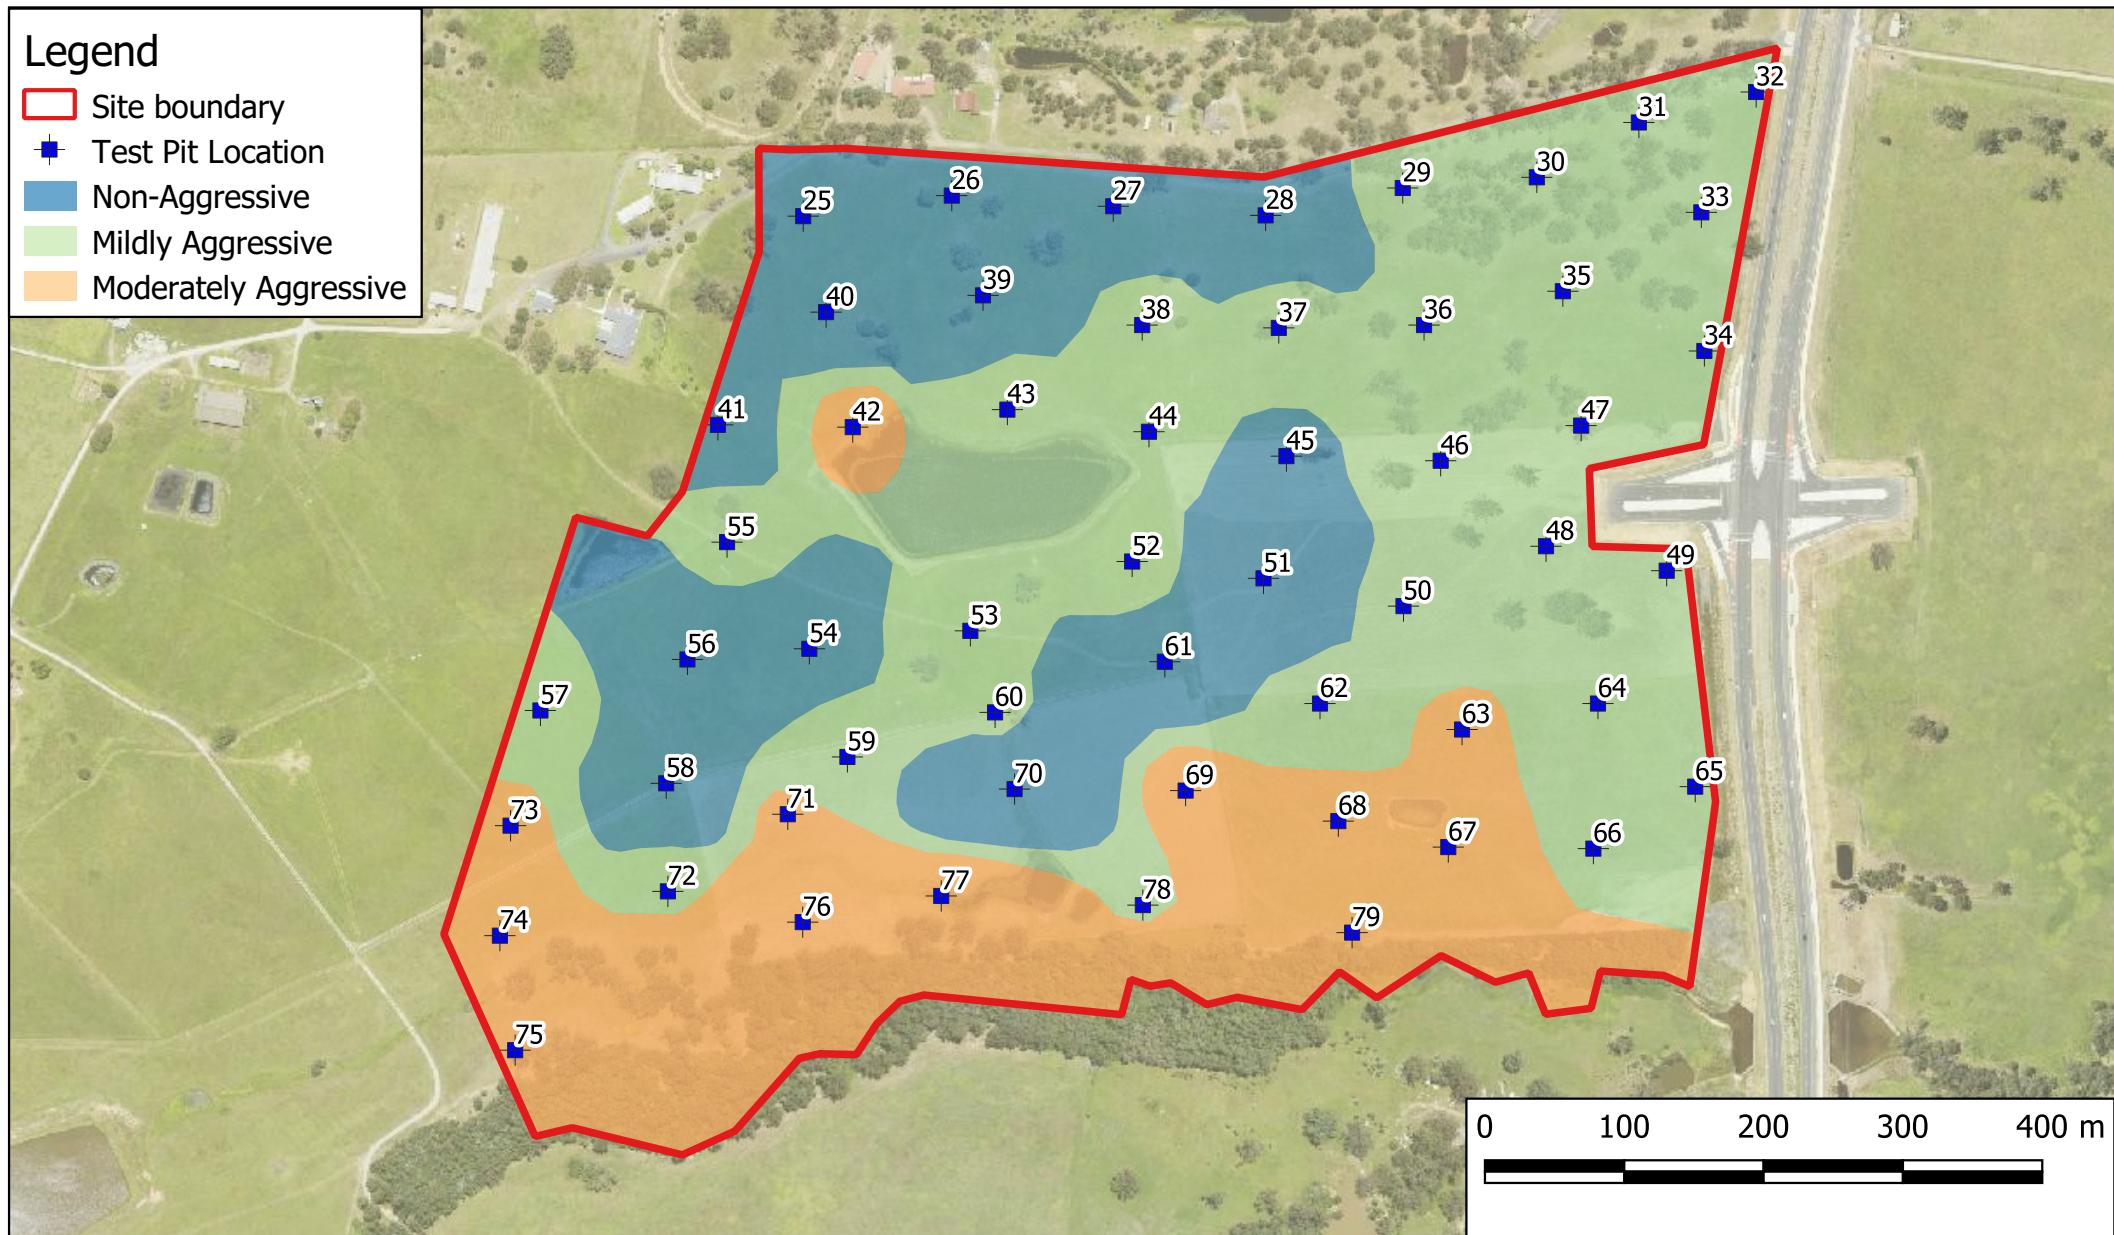
TITLE: Aggressivity to Steel within Investigated Depth Zone
Proposed Stage 1 Birling - Residential Subdivision
975 The Northern Road, Bringelly, NSW

K. Resistivity results indicate soils within the site that are mildly and moderately aggressive to steel (refer Drawing 3, Appendix A). The following corrosion allowances (as per AS 2159 – 2009) should be taken into account by the designer:

- Mild: uniform corrosion allowance 0.01 – 0.02 mm/year;
- Moderate: uniform corrosion allowance 0.02 – 0.04 mm/year.

In instances where a coating is applied to the pile, if the design life of the pile is greater than the design life for the coating, consideration must be given to corrosion of the pile in accordance with the above list.
